TEST REPORT

Ph: 909.472.4100 • Fax 909.472.4243 • Web: www.iapmo.org 5001 East Philadelphia Street • Ontario, California 91761-2816 - USA

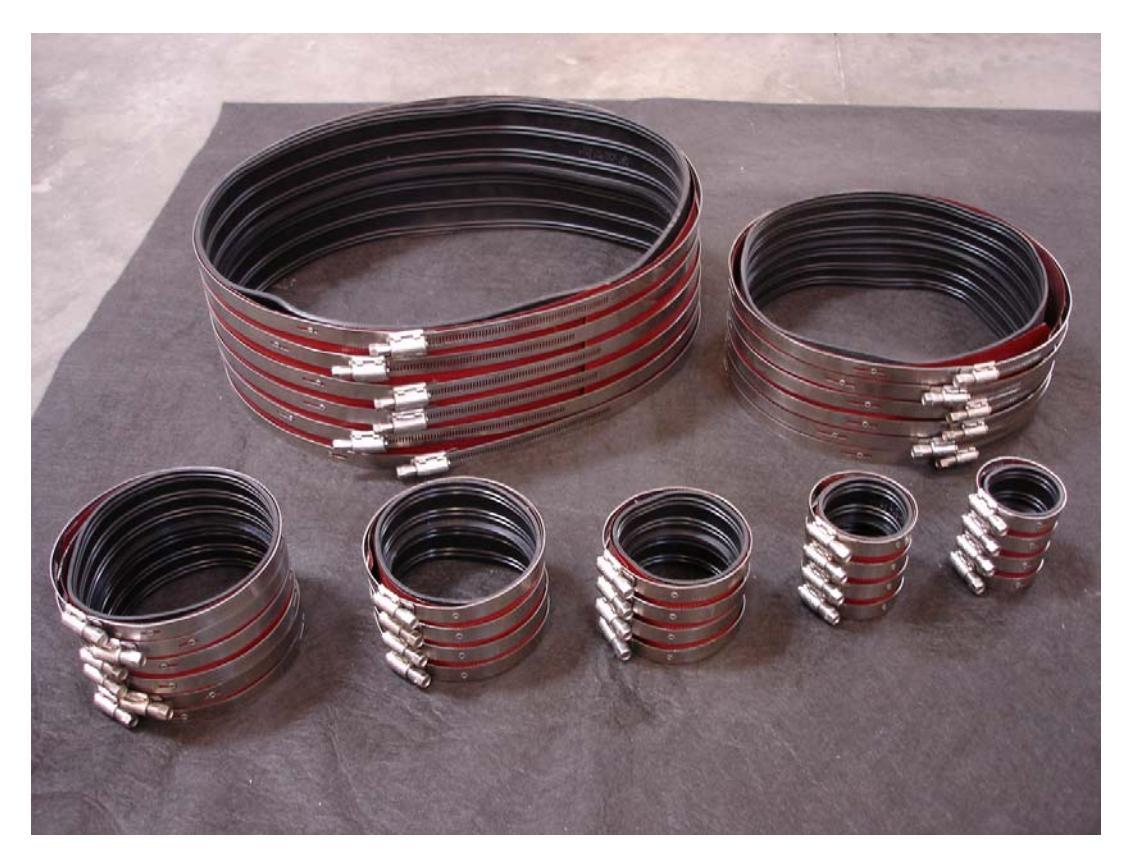
Photograph of samples
