**MI-SPF-100**

**WATER CLOSET  
REPAIR FLANGE**

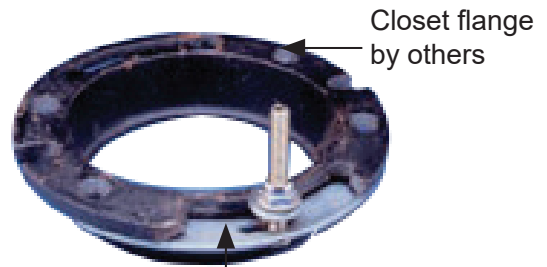
**Application image  
MI-SPF-100**

Install the MI-SPF-100 here,  
underneath the nut.

**Specification:** MIFAB®'s MI-SPF-100 fabricated 10 gauge steel, powder epoxy coated water closet repair flange with alignment slots.

**Function:** MIFAB's MI-SPF-100 is used to repair broken toilet flanges. It permits the repair of broken toilet flanges without having to replace the entire toilet flange. Simply install the MI-SPF-100 under the broken area of the closet flange and tighten the nut. Applicable for all cast iron, plastic, copper and brass toilet flanges.
